Damage to Concrete Structures

Geert De Schutter

This book explains how damage can occur to concrete structures. The contents of the different chapters are structured along the timing of the actions leading to damage. Damage can occur due to inappropriate design, errors during execution, some mechanisms occurring during hardening of the concrete, or actions or degradation mechanisms during service life (hardened concrete). The different actions or mechanisms are explained in a fundamental way without too many physical or chemical details. The degradation mechanisms are illustrated with many drawings and photographs taken of real structures.

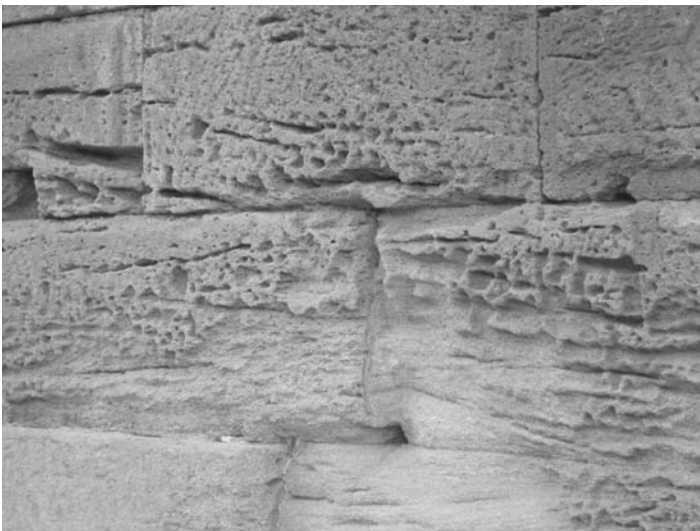
Figure 1.2 Pont du Gard, France, degradation of the limestone.

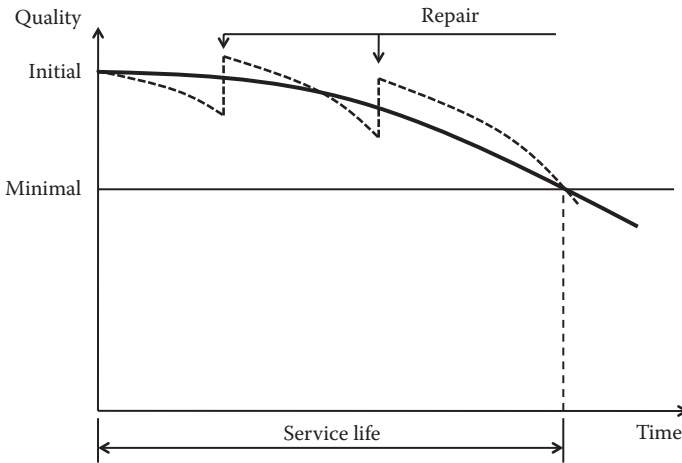
Figure 1.4 Schematic representation of the service life and the effect of repair.

After successful completion of a structure, the initial quality is higher than the minimal required level as shown in Figure 1.4. With time, due to the 'ageing' of the structure, the quality of the structure decreases. In normal conditions, the decreasing quality reaches the minimal required level only at the end of the target service life. In the case of aggressive environment, the rate of quality loss can be very high, possibly leading to an accelerated crossing of the minimal required level, meaning that the target service life is not reached. In this case, repair actions can be necessary to reach the target service life. The effect of repair is visible in Figure 1.4 by a sudden increase in quality of the structure. Distinction can be made between corrective repair in order to rehabilitate the structure after an unforeseen accelerated degradation, or preventive repair anticipating predicted future damage. In principle, for every important structure a specific maintenance and repair strategy should be defined and linked with an adequate inspection and monitoring strategy.

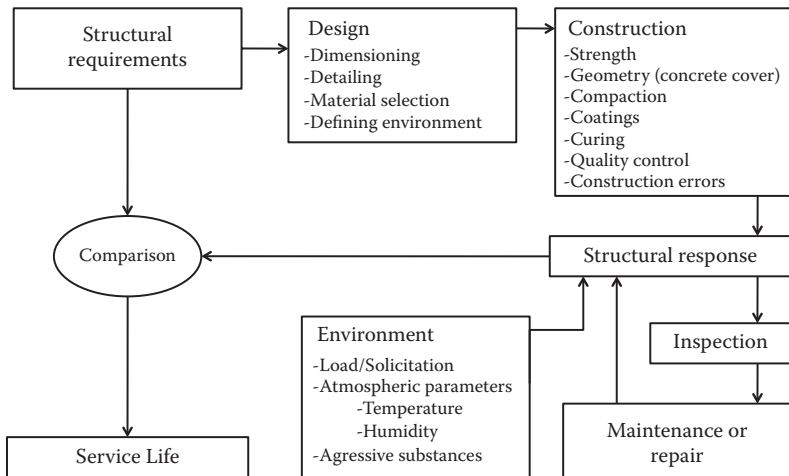
Figure 1.5 Structural response and service life.

The further detailed treatment in this textbook of the degradation mechanisms in concrete structures is more linked to technical or structural requirements. Many factors can influence the structural response of a structure as illustrated in Figure 1.5. First, based on structural requirements, the design stage is very important. During design, the overall dimensions are defined as well as some important construction details. The appropriate materials have to be selected. In the case of concrete structures, this means an appropriate mix design, based on carefully selected constituent materials. All of this should be in good agreement with the future environment of the structure to be designed.

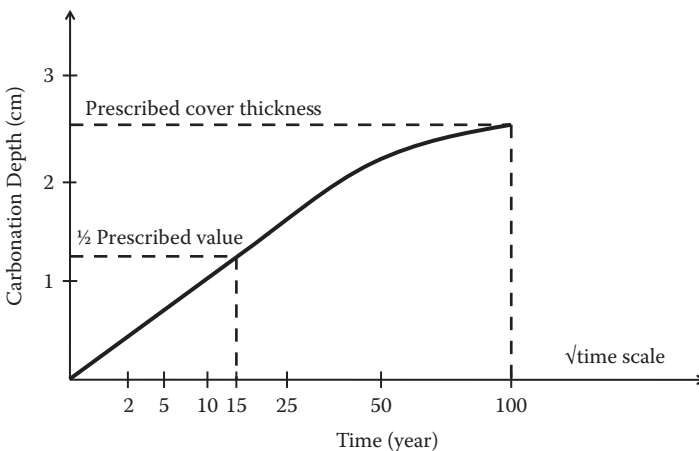
Figure 1.9 Effect of reduced cover thickness on service life in case of carbonation.

During casting, due attention has to be given to the cover thickness. Positioning of formwork and reinforcement cages should be done with utmost care in order to avoid too low values of the cover thickness. Prescribed cover thickness values should be considered as minimum values and should be carefully respected in practice by appropriate use of spacers. The cover thickness is very important in order to avoid reinforcement corrosion due to carbonation or chloride penetration. The concrete within the cover zone, the so-called ‘covercrete’, provides a barrier against carbon dioxide and chloride ions. The higher the cover thickness, the longer it takes before the carbonation depth or a critical chloride content reaches the steel reinforcement (see Chapter 5). It is important to realize that the time it takes for the carbonation front to reach the steel reinforcement is not linearly proportional to the cover thickness. The carbonation depth is typically more or less proportional to the square root of time with some retardation at later age (Figure 1.9).

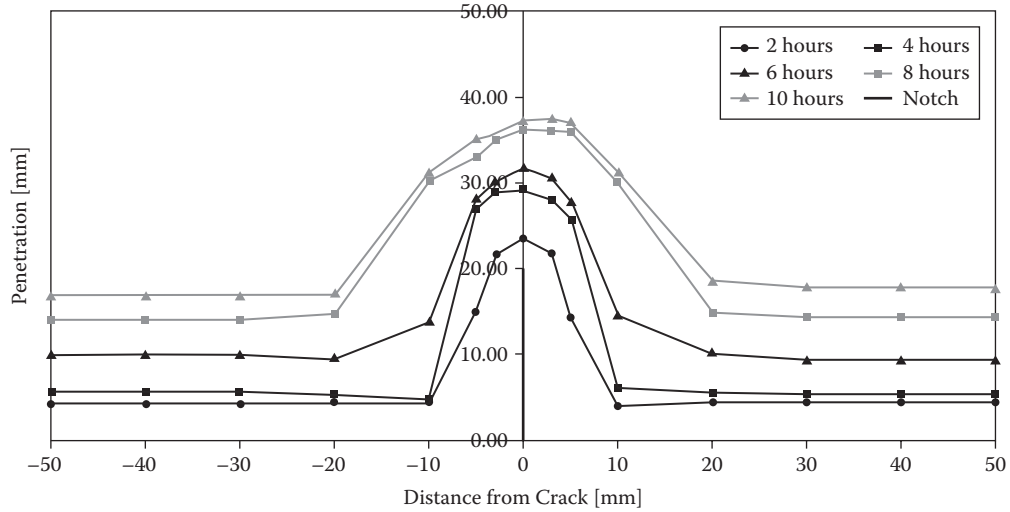
Figure 1.11 Influence of cracks (width 0.3 mm, depth 20 mm) on accelerated chloride migration in laboratory test.

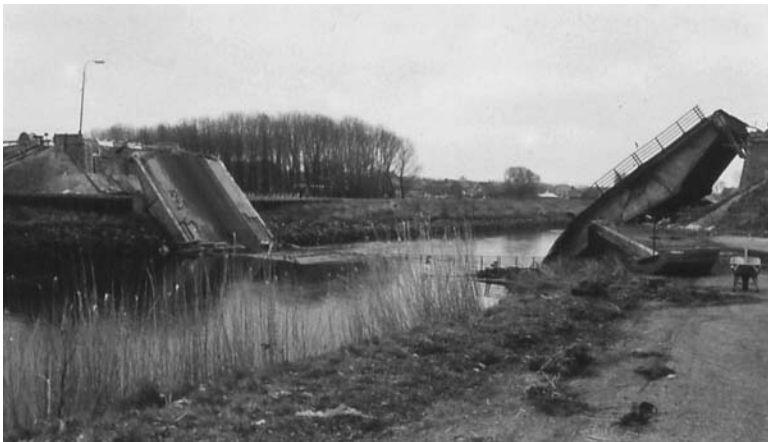
Figure 2.1 Collapse of the Melle Bridge, Belgium, 1991.

The hinge was provided by reducing the concrete section to one third of the full section, leaving only about 5 cm of concrete with centrally positioned prestressing wires. The concrete cover thickness protecting the wires thus was locally reduced to less than 20 mm. Furthermore, due to the hinging action, this section contained microcracking, which further accelerated the penetration of chloride containing de-icing salts towards the prestressing wires, which are very sensitive to chloride-induced corrosion. As a result, the prestressing wires were strongly corroded, as can be seen in Figure 2.4, leading to a severely reduced load carrying capacity of the tensile pendulum pillars. After about twenty-five years of service, progressive failure occurred while the bridge was loaded by the gasoline truck. One of

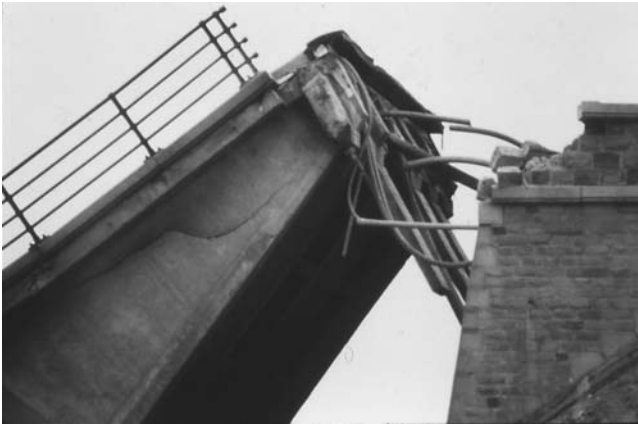
Figure 2.3 Picture of the tensile pendulum pillars (after failure).

the pendulum pillars failed, leading to a load increase in the other pendulums, which in their turn failed. Due to the failure of the tensile pendulum pillars, a moment redistribution occurred in the main span of the bridge, leading to values higher than the design value. As a consequence, the main span also failed, ending in the complete collapse of the Melle Bridge.

In summary, a design detail (the hinges) indirectly caused the collapse of the bridge. Unfortunately, the bridge seemed not very robust. Although the bridge was hyperstatic (statically indeterminate), failure of the pendulums immediately provoked failure in the main span, giving a nice but

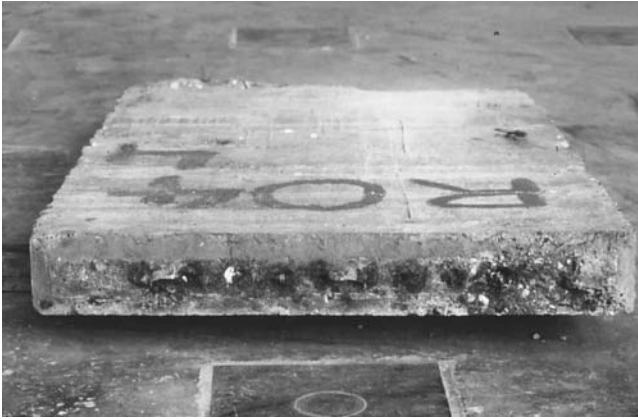
Figure 2.4 View of failed hinge of tensile pendulum pillar (with corroded prestressing wires).

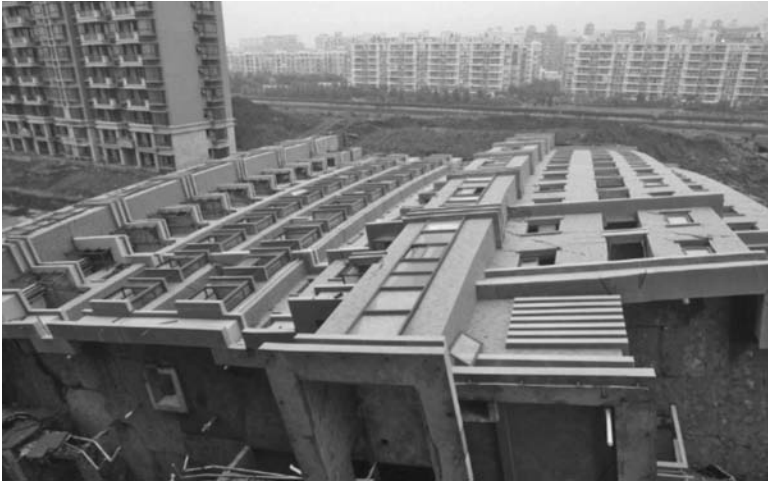
Figure 2.5 Tumbling collapse of apartment building in Shanghai, 2009 (Internet photo).

On June 27, 2009, a nearly finished 13-storey apartment building in Shanghai just tumbled over, killing one worker (see Figure 2.5). As in many collapses,

a combination of several aspects led to this disaster, most likely including inappropriate design, improper construction methods, and lack of control.

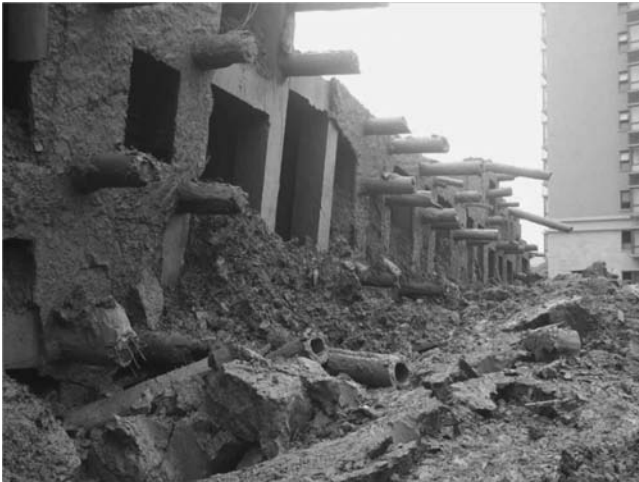
Figure 2.6 Detail of the foundation piles (Internet photo).

Figure 2.6 shows a detailed picture of the foundation of the apartment building, including part of the foundation piles. According to Gregory (2009), part of the explanation for the collapse is related to the design of the foundation. He refers to the chairman of the Japan Structural Consultants, who said that ‘judging from Japan’s standards, the posts of the building are

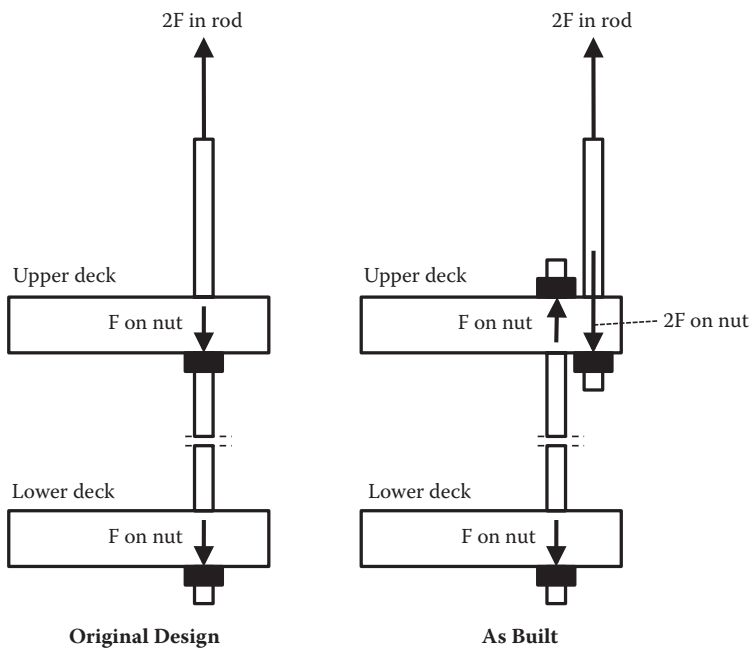
Figure 2.7 Hyatt Regency walkway: original design and situation as built.

On 17 July 1981, while hundreds of people were enjoying a music performance in the atrium of the Hyatt Regency, Kansas City, Kansas, USA, the suspended walkway suddenly collapsed, killing 114 and injuring many more (Petroski 1982, Natarajan 2007). The reason for the collapse was the failure of the connection between the upper deck and the suspension rods (Figure 2.7). While originally designed otherwise, the walkway was actually constructed with two separate rods (one for each rod, with the lower attached to the upper deck) instead of one single rod. As mentioned

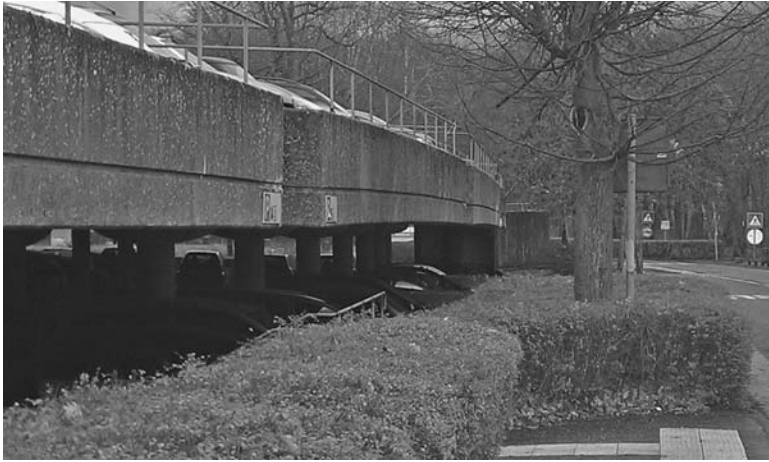
Figure 2.8 Long-term creep deformations of concrete parking structure.

In case of long-span bridges, the increased deflection due to creep effects can clearly become visible, especially when looking in longitudinal direction. Creep effects can also be visible in other structures, as shown in Figure 2.8. Although these creep deformations will not directly impair the load bearing capacity of the structure, the excessive deformations are not esthetic and might give an unsafe feeling.

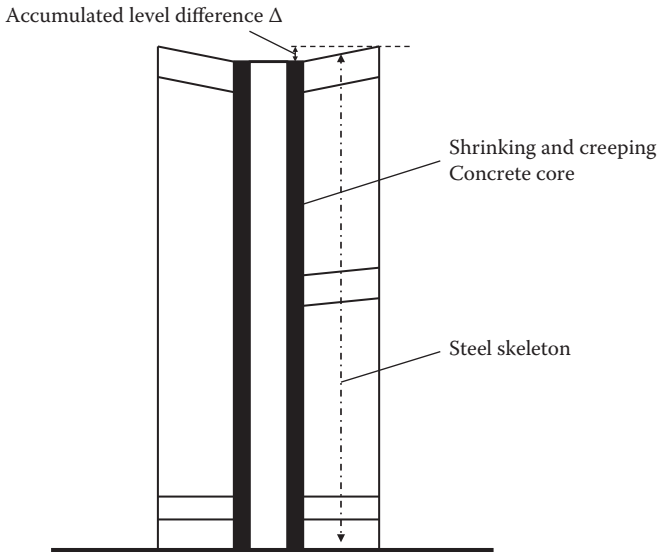
Figure 2.10 Effect of concrete core creep and shrinkage in tall buildings.

In tall buildings, unexpected situations can also occur when neglecting creep effects in concrete. Tall buildings typically consist of a central stiff core made in concrete, surrounded by a steel skeleton for the construction of the different floor levels. Due to creep and shrinkage of the concrete core,

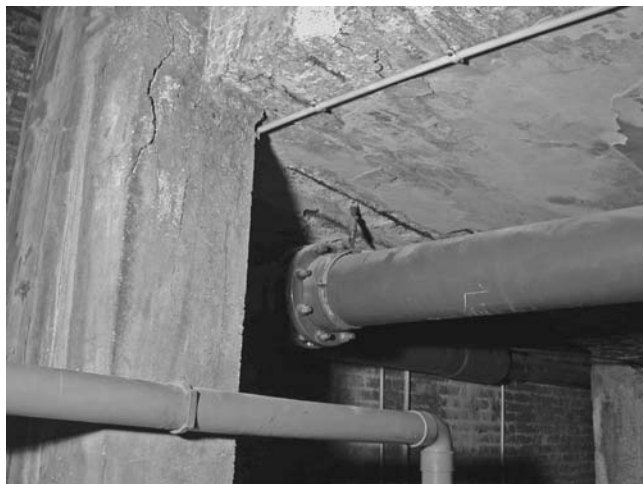
Figure 2.11 Degradation of concrete in the technical area underneath a swimming pool.

Quite often it is considered that no particular requirements have to be defined for the concrete type applied for the construction of swimming pools, reasoning that the concrete will be protected by a water-tight membrane protecting it from the chloride containing pool water. Apart from the significant impact of leaks in the membrane, this approach does not duly consider the fact that the main risk of concrete degradation in swimming pools is more typically situated in the technical areas underneath or alongside the pool itself (Figure 2.11). In these technical areas, a chloride containing environment is available, quite often at higher temperature (even up to 30°C). In many cases, water leaks containing chlorides are also occurring in pumps or pipes. These conditions can lead to an accelerated degradation of the concrete of the pool when an inappropriate concrete type (e.g. too high water/cement ratio) has been selected.

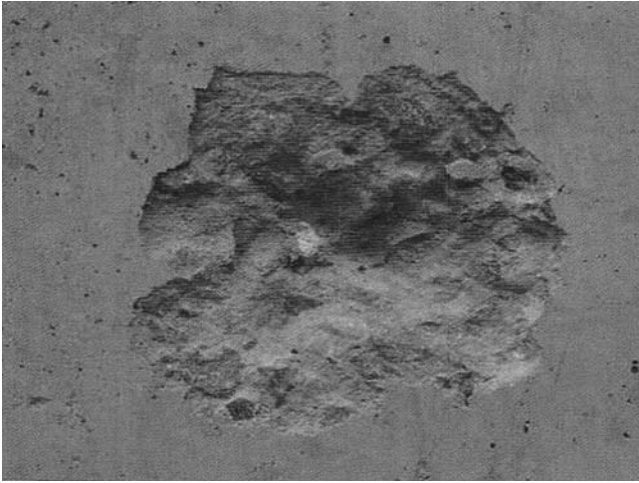
Figure 3.1 Pop-out due to free lime particles.

Free lime, CaO , will hydrate when present in concrete and will form calcium hydroxide, $\text{Ca}(\text{OH})_2$. This hydration process is expansive and can

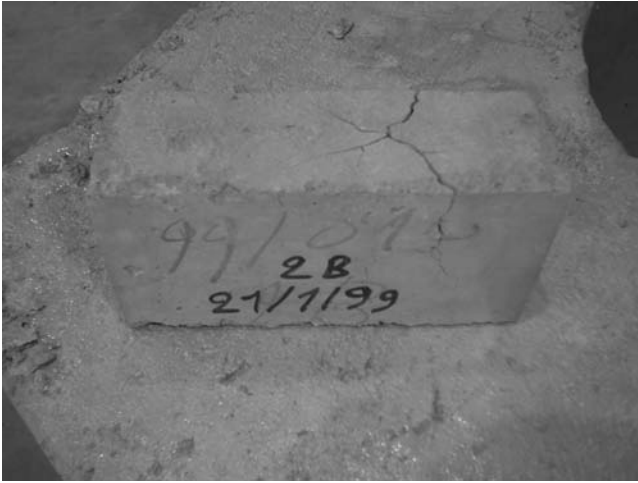
Figure 3.2 Disintegration of a concrete block containing non-stabilized slag particles.

Care should also be taken when using by-products or waste-products as aggregates in concrete. It should be verified whether the alternative aggregate particles are stable enough so that expansive reactions and consequent cracking can be avoided. As an example, Figure 3.2 shows a disintegrating concrete block containing non-stabilized LD-slag as aggregate particles. LD-slag is an industrial by-product resulting from the transformation of hot metal into steel by oxygen refining. Most of the oxides formed are fixed into a basic slag built by the addition of lime and by the combustion of some iron and manganese. Consequently, LD-slag is a crystalline product containing mainly calcium silicate and combinations of lime and iron oxides. However, without any further treatment the LD-slag shows an insufficient volume stability, resulting in an expansive reaction and concrete damage. To overcome this problem, treated LD-slag has to be used. Methods to increase the volume stability are weathering with water or steam, thermal mixing with other products such as glass or sand, and cold mixing with incinerator bottom ashes or blast furnace sand (De Schutter et al. 2001).

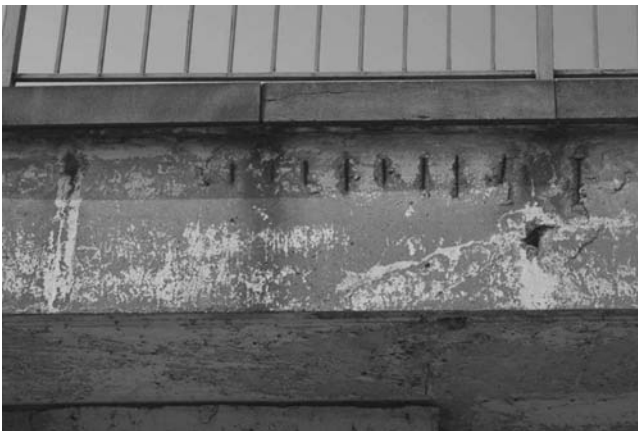
Figure 3.6 Reinforcement corrosion in case of insufficient cover thickness.

Due attention should then be given to a correct positioning of the reinforcement cage, avoiding shifting of the cage towards the formwork during casting as illustrated in Figure 3.5. This can be easily done by providing spacers with the right size and insufficient quantities and by inspecting over spacing before concrete placement. Failing to do so can lead to accelerated corrosion of the reinforcing bars which are too close to the surface, clearly making them visible due to expansive corrosion and subsequent concrete spalling as seen in Figure 3.6.

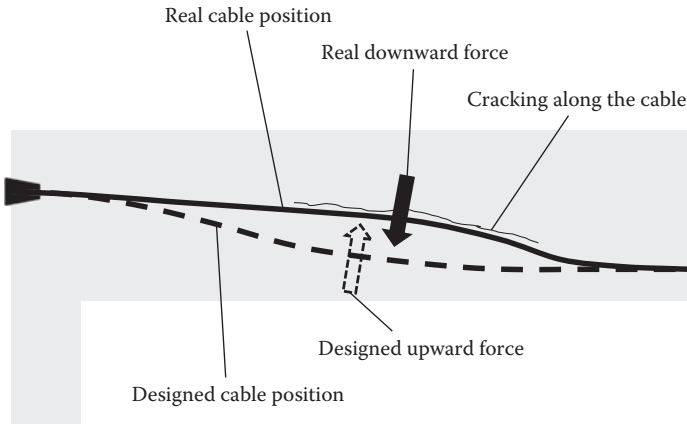
Figure 3.7 Wrong positioning of prestressing cables.

When the cable is positioned correctly, it will generate upward forces in the concrete beam, counteracting the downward forces provided by self-weight of the beam or by live load. This is how the prestressed cable increases the load bearing capacity of the concrete beam, compensating for (part of) the external loading, and making sure that no (or only limited) tensile stresses occur in the concrete.

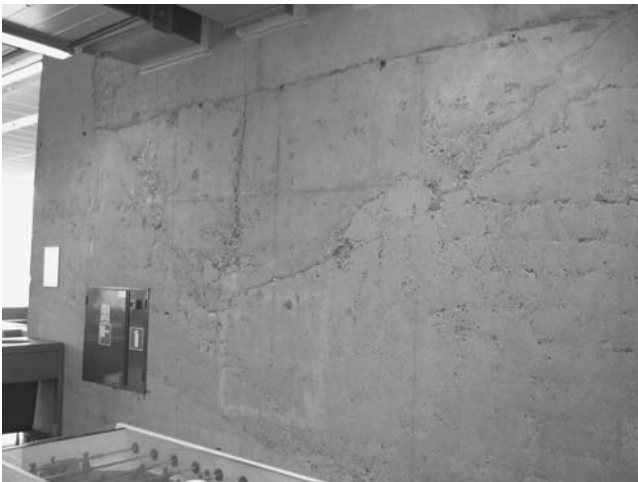
Figure 3.8 Visual defects due to inappropriate compaction of a concrete wall.

Figure 3.8 also shows some casting joints, which can be partly linked to compaction problems, but also to a delay between different batches and inappropriate preparation of the surface of the previously already set or

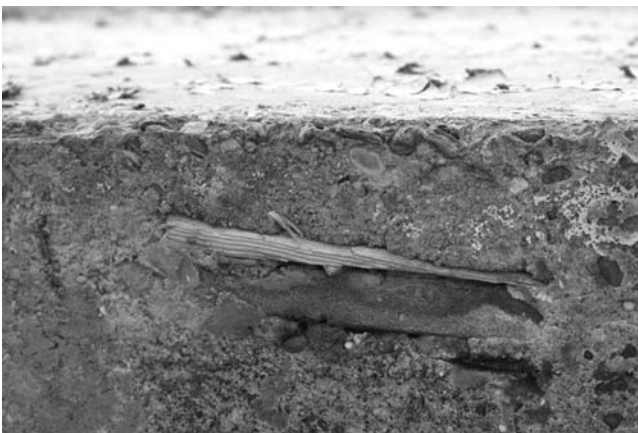
Figure 3.10 Unwanted inclusions in concrete.

During casting, unwanted inclusions can also be entrapped into the fresh concrete. In many cases, these inclusions remain invisible and unknown, although sometimes they become apparent on the final concrete surface, as illustrated in Figure 3.10 where some timber leftovers have been entrapped.

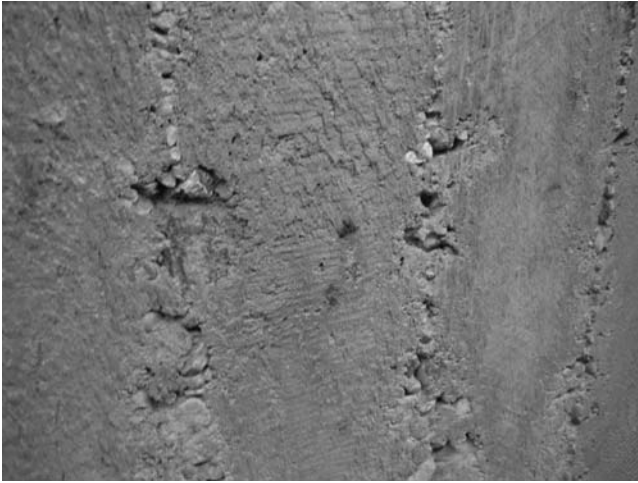
Figure 3.11 Surface defects and honeycombed concrete due to leaking formworks.

When formworks are leaking, water and fine particles (cement, powders, fine sand) can be drained away, leaving unacceptable surface defects and honeycombed concrete as shown in Figure 3.11. A good tightness of the

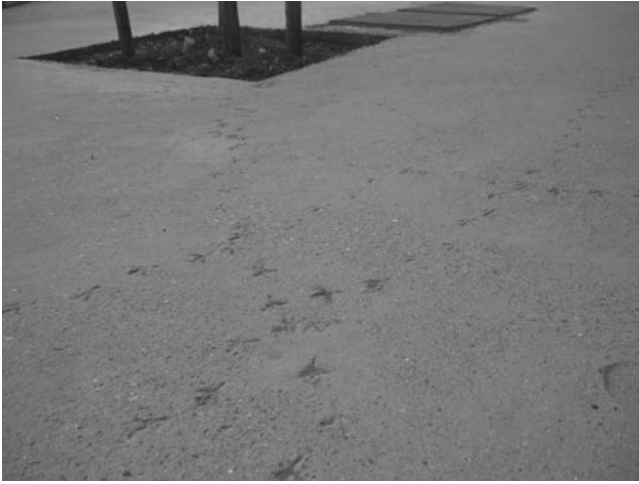
Figure 3.15 Damage by animals walking in freshly cast concrete.

During the plastic stage, the first hours after casting, damage could be caused to the finished concrete surface by early loading, e.g. bikes driving too early on a very recently finished pathway, or even animals walking in the fresh concrete (see Figure 3.15). However, more frequently occurring problems in the plastic stage are plastic shrinkage, plastic settlement, and bleeding.

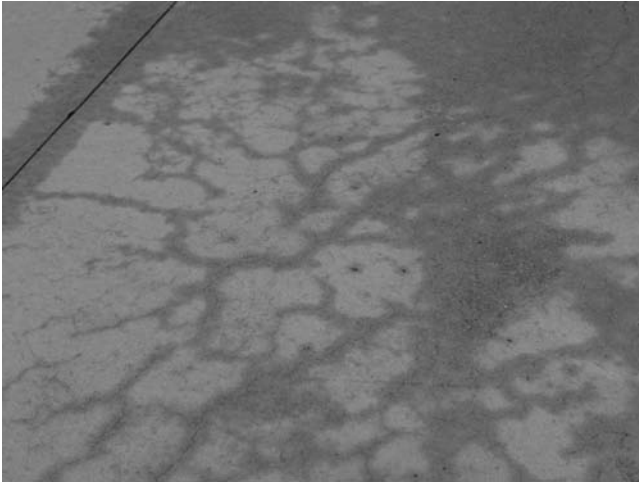
Figure 3.17 Typical plastic shrinkage map-like crack pattern in a concrete slab.

A typical map-like plastic-shrinkage crack pattern is shown in Figure 3.17. However, in case of a strong wind in a quite steady direction, a pattern of mainly parallel plastic-shrinkage cracks can also occur as shown in Figure 3.18. In this case, as wind is a driving force, the plastic cracks are commonly referred to as wind cracks.

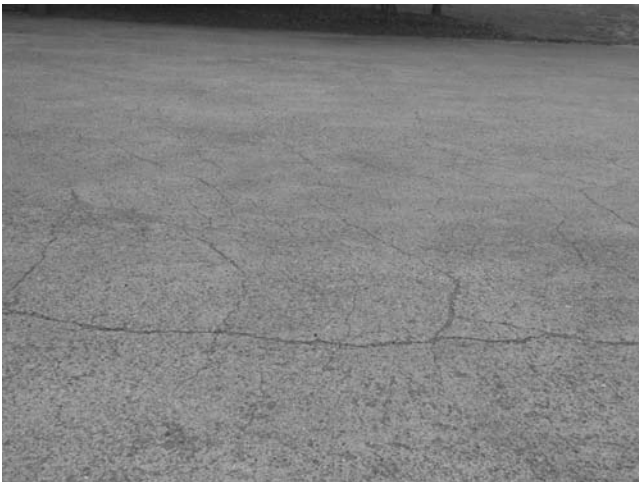
Figure 3.18 Parallel plastic-shrinkage cracks (wind cracks).

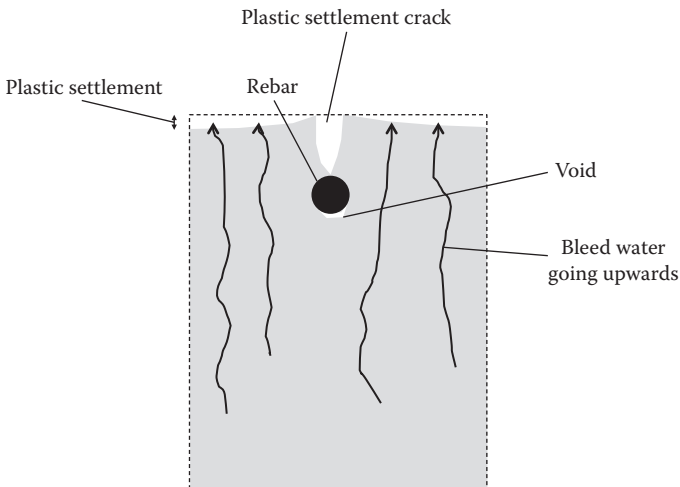
Figure 3.19 Plastic settlement and bleeding.

In thicker concrete elements, plastic settlement and bleeding can lead to surface cracks following the upper reinforcement bars as illustrated in Figure 3.19. This is due to the fact that the reinforcement bars are fixed

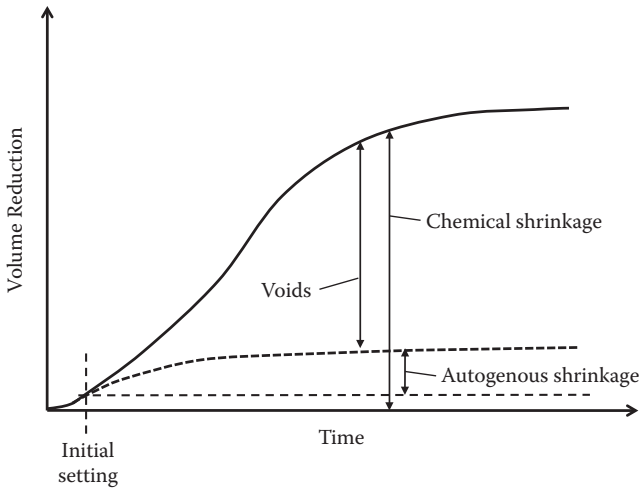
Figure 4.2 Correspondence between autogenous and chemical shrinkage.

The correspondence between chemical shrinkage and autogenous shrinkage is illustrated in Figure 4.2. Immediately after water addition, the hydration process evolves, introducing chemical shrinkage into the cement-based system. As soon as setting initiates, the effects of chemical shrinkage and self-desiccation cause a macroscopic volume reduction of the hardening material, called autogenous shrinkage, which is much smaller than the purely chemical shrinkage. The difference between chemical shrinkage and autogenous shrinkage represents the volume of voids formed into the system due to hydration.

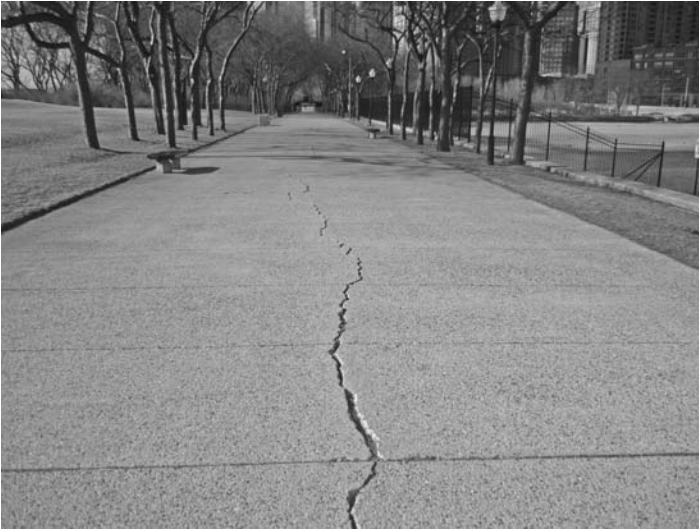
Figure 4.5 Drying shrinkage cracking in walkway.

casting and setting. In the example of Figure 4.5, joints have been provided at regular short distances in the longitudinal direction of the concrete walkway. However, in the transversal direction, no joints or saw cuts have been provided, yielding slab elements which are too long to avoid drying shrinkage cracking due to external restraint. As a result, a major crack occurred about halfway, running along the walkway.

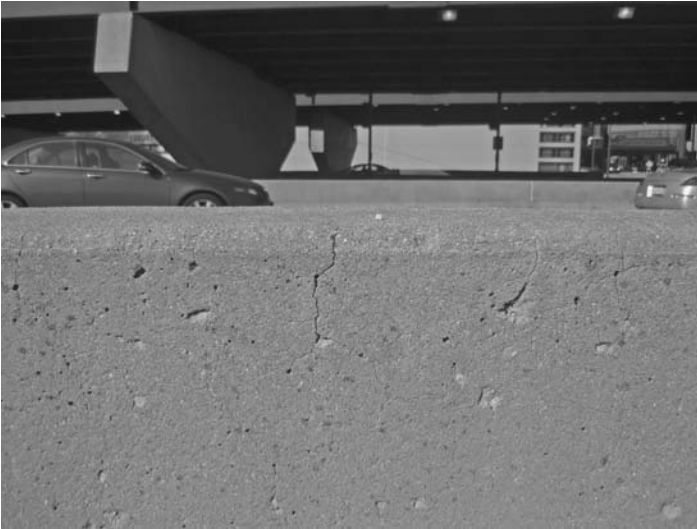
Figure 4.6 Drying shrinkage cracking in New Jersey concrete barriers.

Drying shrinkage cracking also typically occurs in linear elements such as New Jersey concrete barriers employed to separate lanes of traffic, as illustrated in Figure 4.6. Heavy reinforcement in these barriers will not prevent cracking due to drying shrinkage, but can help distribute cracks and limit crack widths. This principle is also followed in the case of continuously reinforced concrete highways without joints: cracks are not avoided, but rather controlled due to heavy reinforcement.

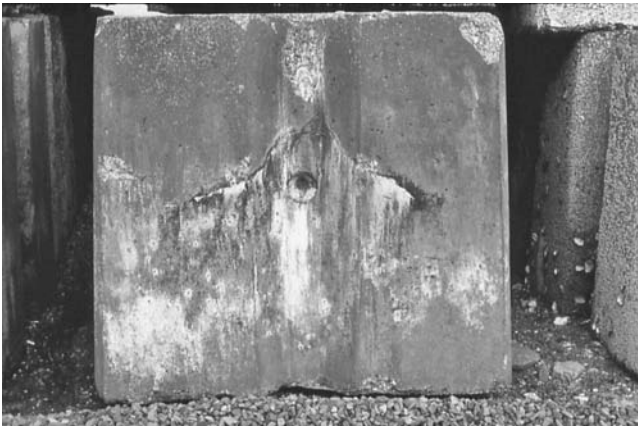
Figure 4.10 Early-age thermal cracks in grooved cube concrete armour unit.

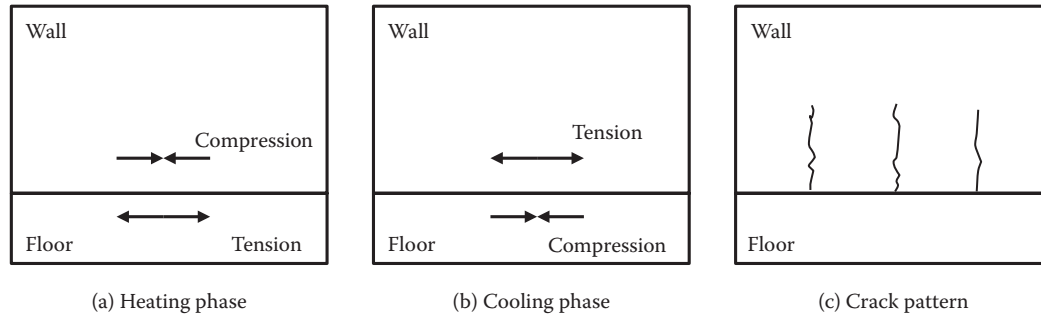
Figure 4.11 Early-age thermal cracking due to external restraint: example of a hardening wall on a previously cast floor or foundation.

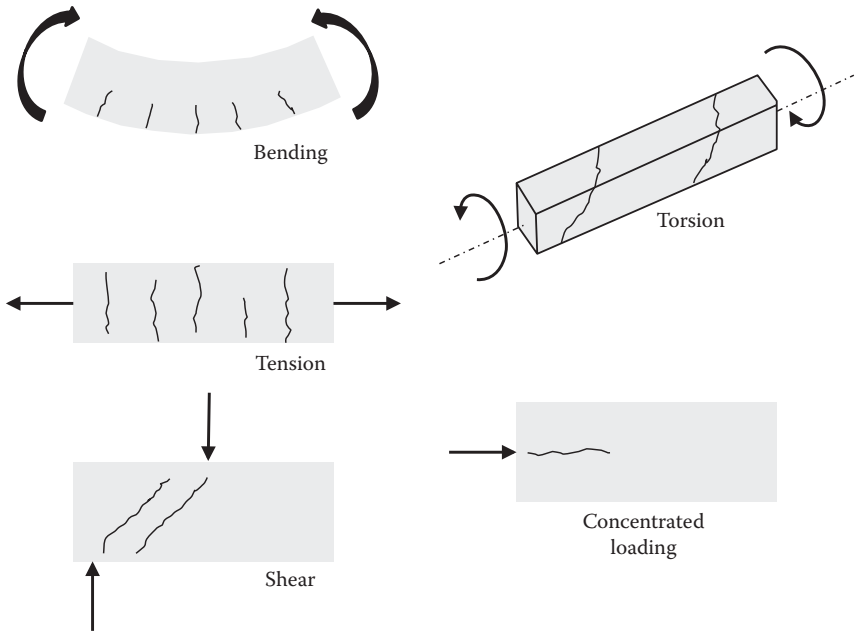
Figure 5.1 Crack patterns due to direct loading.

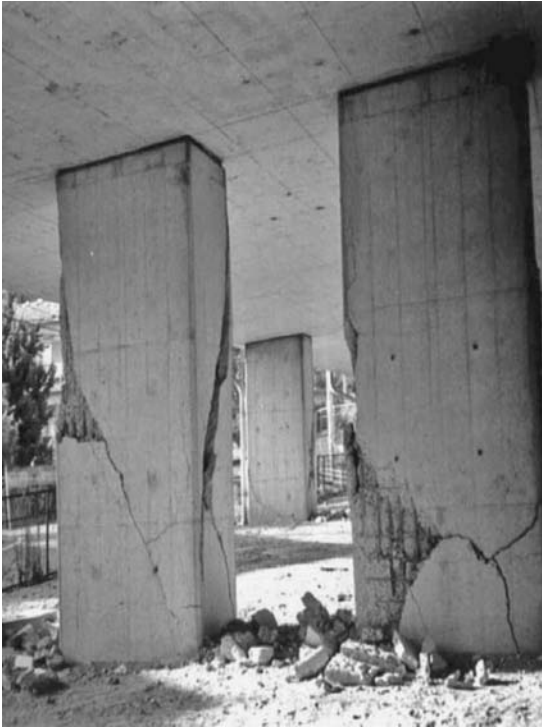
Figure 5.2 Damage to concrete columns due to earthquake loading (Internet photo).

Significant damage to concrete structures can also be caused by direct loading due to earthquakes. In cases where no special provisions have been taken against loading by earthquakes, structures can totally collapse, causing many casualties. Many countries situated in active earthquake zones have special requirements concerning the design of concrete structures. Even in these countries, earthquakes can still severely damage concrete structures, as illustrated in Figure 5.2.

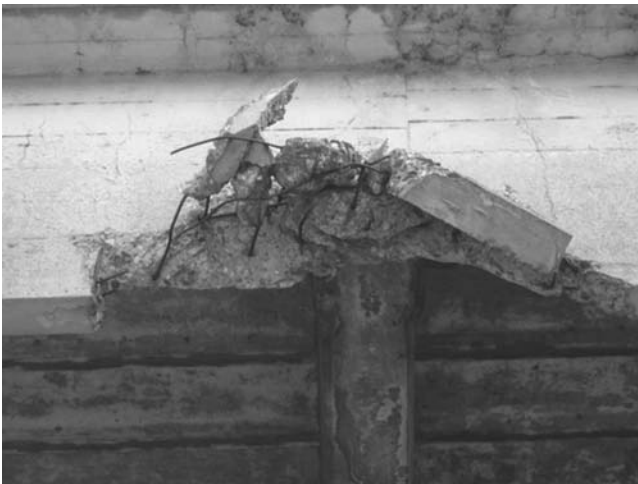
Figure 5.3 Impact damage to concrete girder by truck.

Another case of direct loading is impact. This can be due to explosions (e.g. industrial accidents or terrorist attacks) or traffic accidents. A typical example of this is shown in Figure 5.3, which shows damage to a concrete girder after it was hit by a truck that failed to respect the height limits. In these cases, the remaining structural capacity of the girders must be carefully examined, considering possible damage to the prestressing wires or cables in the case of prestressed bridge girders.

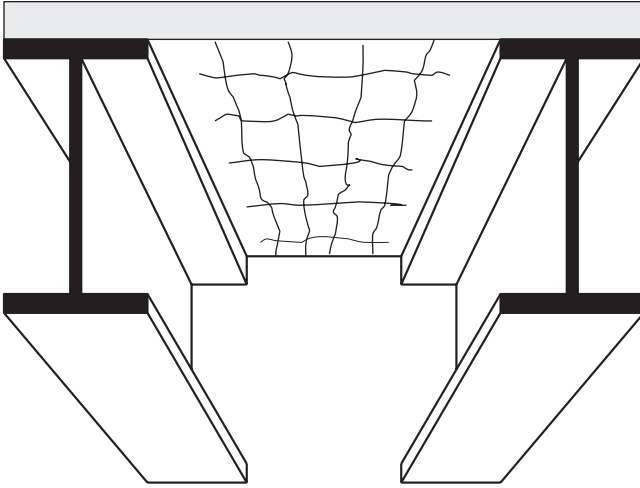
Figure 5.4 Fatigue damage in a thin floor slab of a reinforced concrete bridge.

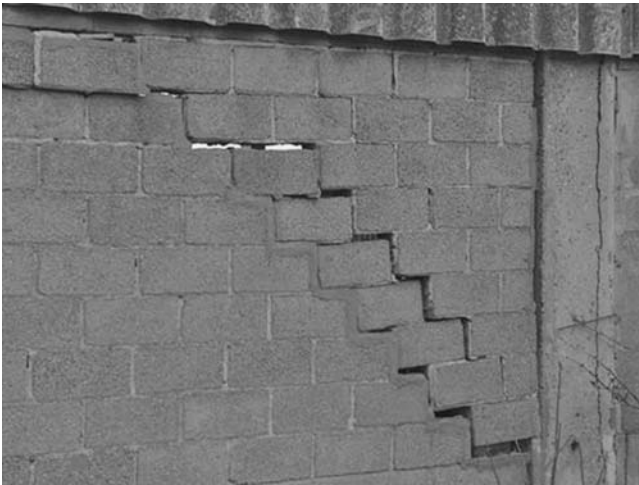
Figure 5.6 Effect of differential settlements on a concrete brick wall.

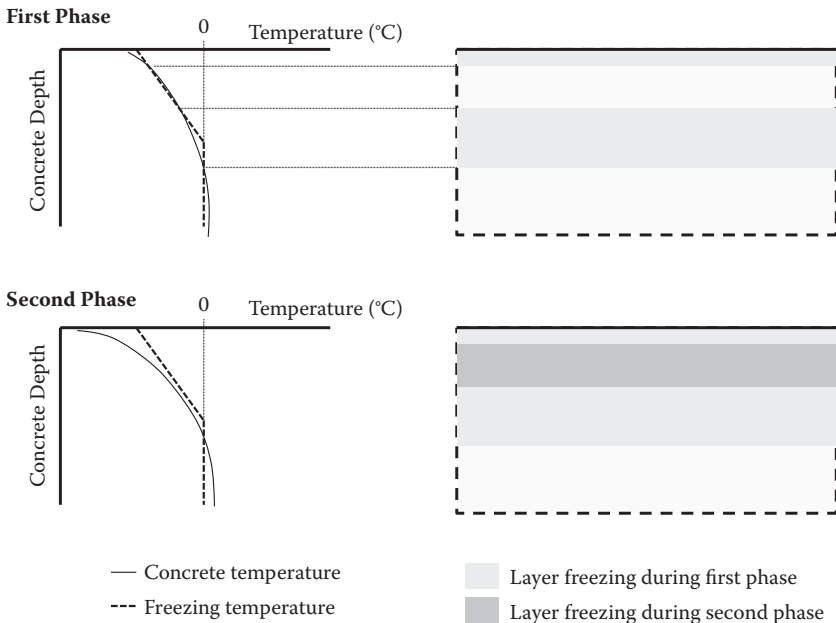
Figure 5.9 Effect of salt concentration gradient on freezing temperature and salt scaling.

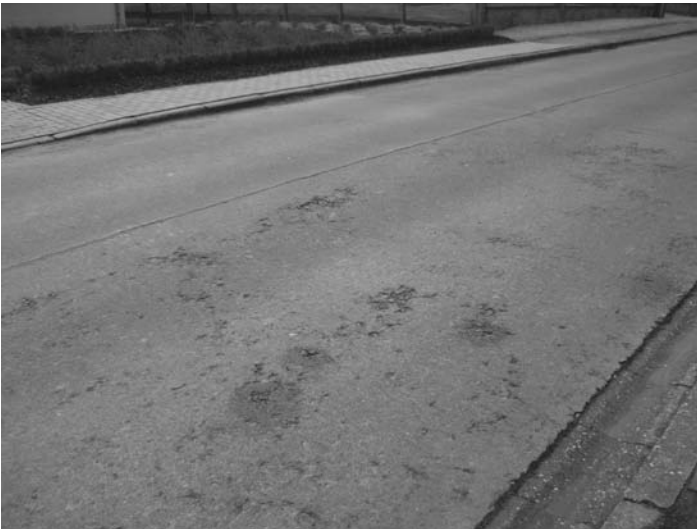
Figure 5.12 Salt scaling on a concrete road.

Frost scaling typically occurs on concrete roads and pavements exposed to de-icing salts. Figure 5.12 shows the resultant damage pattern in the case of a local concrete road exposed to de-icing salts in winter time. Due to traffic loading, the degradation of the concrete road can continue even after winter ends.

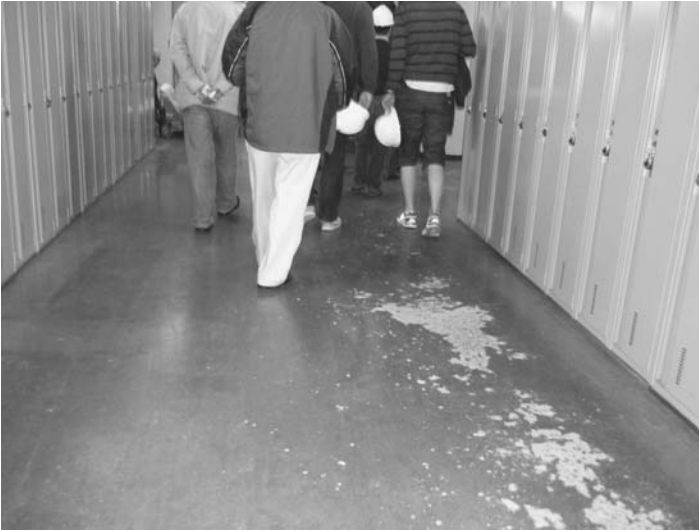
Figure 5.13 Abrasion of concrete floor by intensive walking and sliding near a range of lockers.

In order to clean concrete surfaces, e.g. in view of some rehabilitation activities, sand blasting is a very popular technique. Sand particles are projected onto the concrete surface, either in dry form or in suspension. Their abrasive action removes a thin layer of material including dirt particles, leaving a very clean and nice concrete surface. Abrasion is a very efficient cleaning technique when performed in a controlled way. However, the same abrasive action can severely damage concrete structures when performed in a non-controlled way: erosion by abrasion. Not only sand particles can cause abrasion. As mentioned in the definition, all solids, whether in dry state or in suspension, can contribute to abrasion. This includes traffic on roads and even pedestrians on walkways or in corridors (see Figure 5.13).

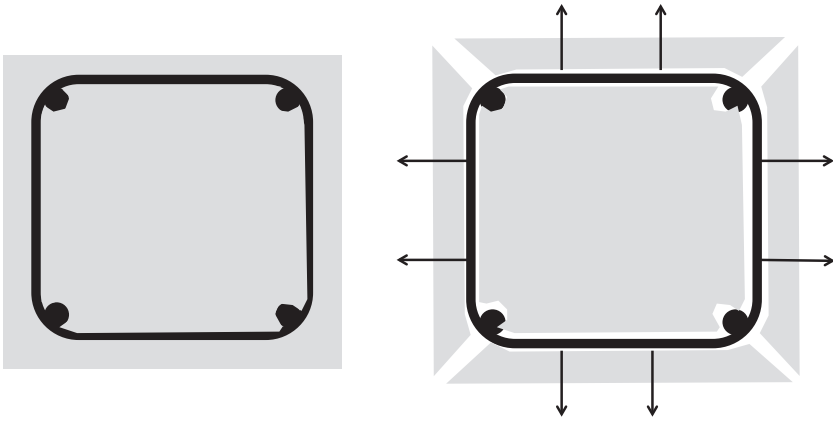
Figure 5.17 Thermal incompatibility between concrete and steel cage due to faster heating of the steel.

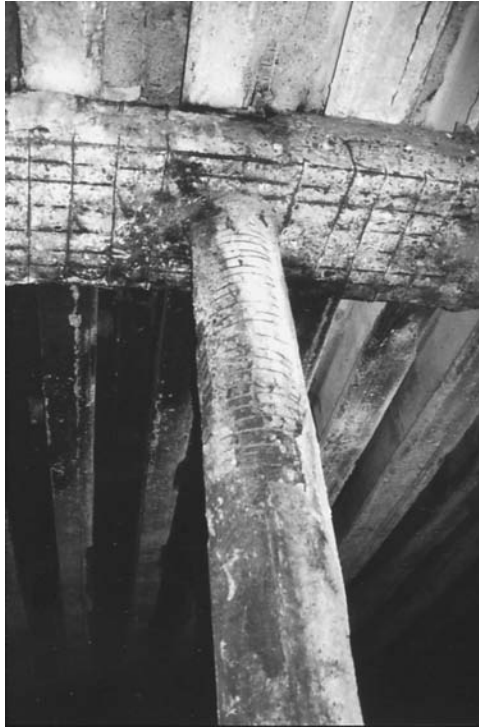
Figure 5.18 Concrete cover pushed off at larger areas due to thermal incompatibility between concrete and steel cage.

to the much higher thermal conductivity. This can lead to another problem of thermal incompatibility, now between the concrete and the steel cage. Due to its higher temperature, the steel cage wants to expand more than the concrete in the core. As a result, as illustrated in Figure 5.17 for the case of a reinforced concrete column exposed to fire conditions, the concrete cover can be pushed off over a larger area. Figure 5.18 shows the example of a real structure suffering from this phenomenon.

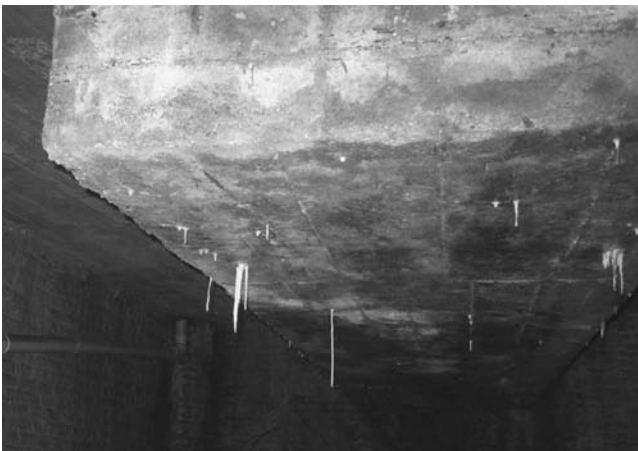
Figure 5.20 Formation of stalactites.

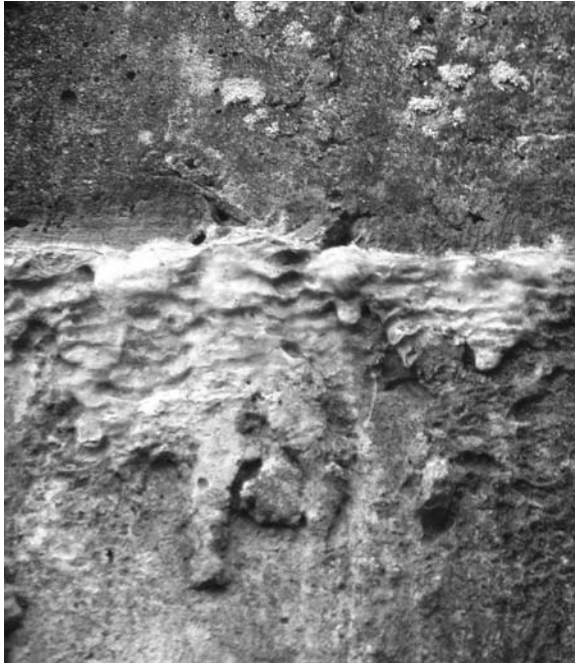
Figure 5.21 Formation of calcium deposits.

Moisture movements in concrete elements due to inadequate water tightness of coatings or roofing can lead to leaching. Calcium ions are dissolved in the moving water and transported toward the concrete surface. After evaporation of the water and reaction with carbon dioxide from the environment, whitish calcium deposits or efflorescence can build up on the concrete surface. As an example, Figure 5.20 shows some stalactites formed on the bottom of a concrete slab in a cellar, while Figure 5.21 shows some calcium deposits on a vertical surface. When other minerals present in the concrete are dissolved, the deposits can have other colours such as yellow or brown.

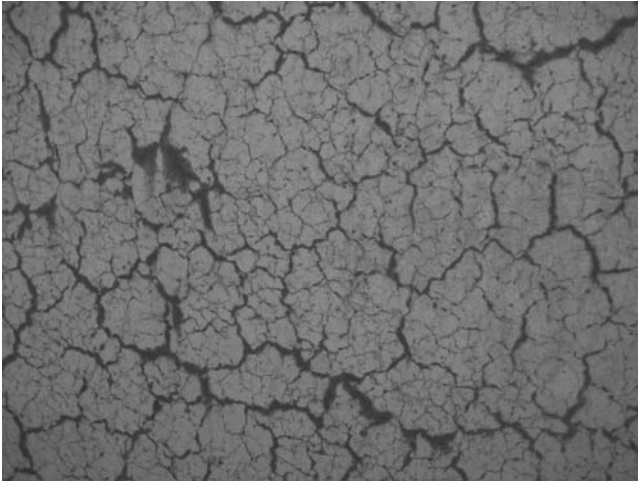
Figure 5.23 Extensive map cracking on the concrete surface due to alkali aggregate reaction.

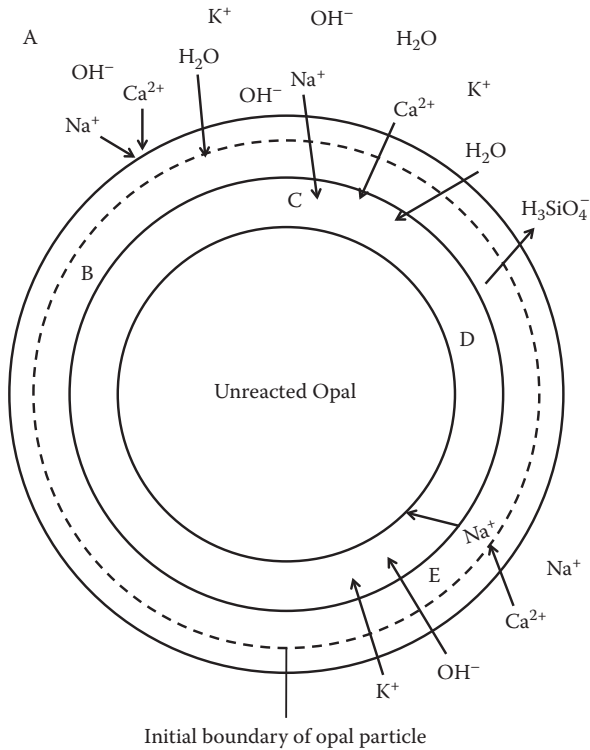
Figure 5.24 Principles of the ASR damage model by Powers and Steinour (1955). A: Pore solution containing H_2O , K^+ , Na^+ , Ca^{2+} , OH^- and H_3SiO_4^- ; B: initial non-swelling C-N-S-H gel, with calcium content depending on the sodium concentration; C: diffusion through gel to react with opal, expansive swelling N-S-H gel in case of low Ca^{2+} content, safe non-swelling C-N-S-H gel in case of high Ca^{2+} content; D: diffusion of H_3SiO_4^- out of the gel in case of safe reaction, while water, Ca^{2+} and Na^+ diffuse into the gel; E: regeneration of Na^+ when Ca^+ reacts with gel.

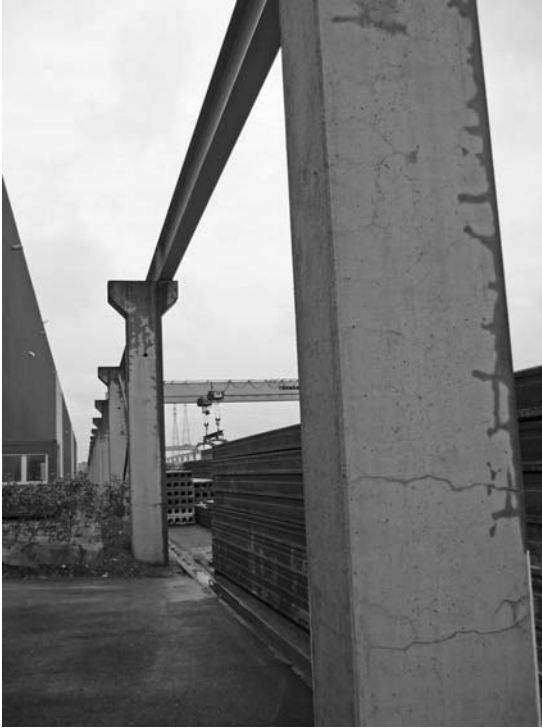
Figure 5.27 ASR in concrete columns.

Cases of ASR can easily be found worldwide. An interesting example is the Montreal Olympic Stadium, which was built for the Olympic Games of 1976. However, despite the fact that ASR is better known nowadays, it can still be found in more recent structures. An example is given in Figure 5.27, which shows concrete columns within a frame supporting a crane bridge in open air. Severe damage due to ASR occurred within less than five years after construction. At the top of the columns, concrete is spalled, yielding

a risk of injuries for the technicians operating the bridge. The concrete contains limestone aggregates from Tournai in Belgium and is made with ordinary Portland cement. In spite of the good concrete quality, severe ASR expansion rapidly occurred in the columns in open air, which were exposed to rain. Identical columns positioned in the construction hall protected from rain also show damage caused by ASR, although it is much less pronounced. This illustrates the important role of moisture on the ASR expansion rate.

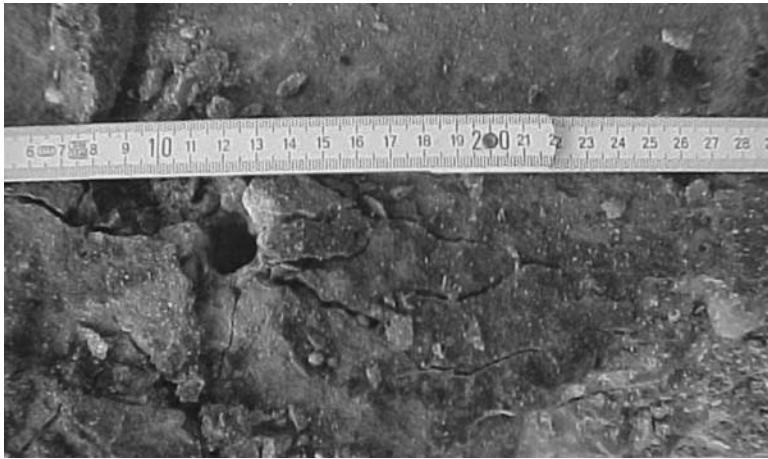
Figure 5.30 Detail of a concrete balcony damaged by expansive chemical sulfate attack (courtesy of SCICON Worldwide bvba).

An illustration of a concrete element internally damaged by chemical sulfate attack through expansive reactions is shown in Figure 5.30. The picture shows a concrete balcony while being rehabilitated, which contains many internal cracks. In the cracks, and in the interface zone around the aggregates, many crystals can be noticed. The expansive damage process was caused by sulfates released from (old type) bituminous materials which had been applied to make the balcony watertight.

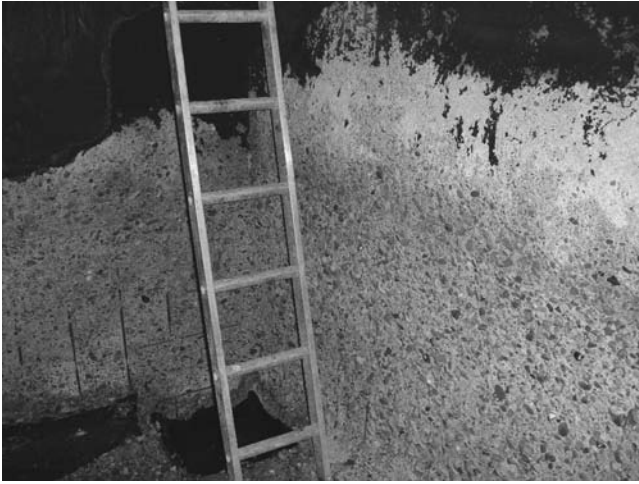
Figure 5.34 Sulfuric acid attack on a concrete wastewater tank in an industrial plant (courtesy of SCICON Worldwide bvba).

Figure 5.34 shows a well advanced case of sulfuric acid attack on a concrete wastewater tank in an industrial plant. The concrete cover disappeared over a large area, making the corroded reinforcement fully visible. In this case, river gravel was used as an aggregate, which resists the acid environment quite well. As it is the cement matrix which was attacked, the damaged concrete has a ‘washed-out’ appearance.
