Damage to Concrete Structures

Geert De Schutter

This book explains how damage can occur to concrete structures. The contents of the different chapters are structured along the timing of the actions leading to damage. Damage can occur due to inappropriate design, errors during execution, some mechanisms occurring during hardening of the concrete, or actions or degradation mechanisms during service life (hardened concrete). The different actions or mechanisms are explained in a fundamental way without too many physical or chemical details. The degradation mechanisms are illustrated with many drawings and photographs taken of real structures.

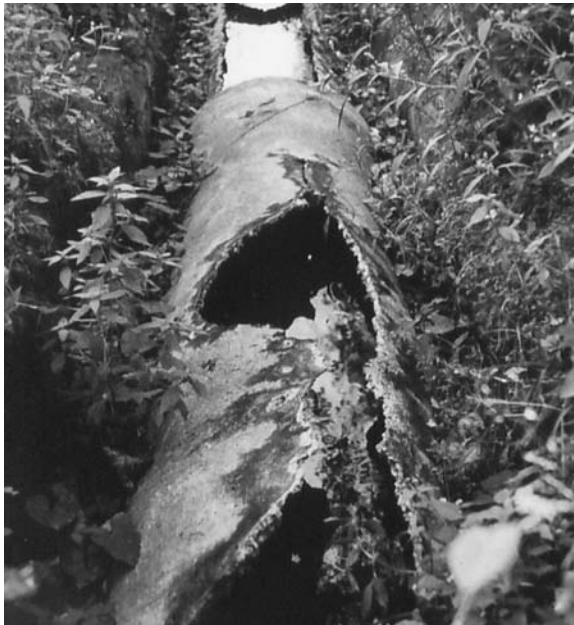
Figure 5.35 Biogenic sulfuric acid attack in a concrete sewer system, totally damaging the upper part of the concrete pipe above the wastewater line.

In concrete sewer systems, it is quite often noticed in practice that severe damage occurs after a very short time, sometimes only a few years. Figure 5.35 shows the remarkable case of a concrete sewer which after

less than 5 years had almost entirely disintegrated. At the very least, it can be observed that the part of the concrete pipe above the wastewater line is heavily damaged and even disappeared over significant lengths. This case was caused by so-called biogenic sulfuric acid attack, which is more aggressive than pure sulfuric acid attack (see Section 5.3.3). The adjective 'biogenic' is added to make clear that micro-organisms or bacteria play an important role in the damage process.

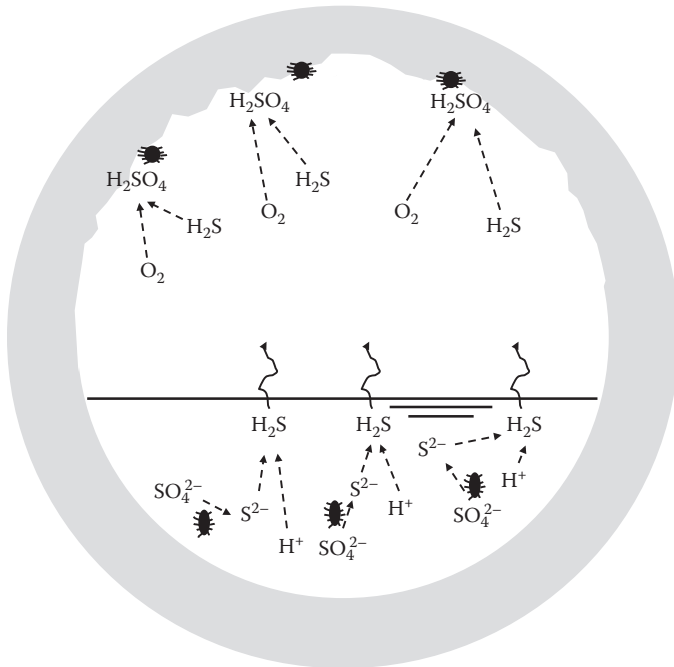
Figure 5.36 Schematic representation of the process involved in biogenic sulfuric acid attack.

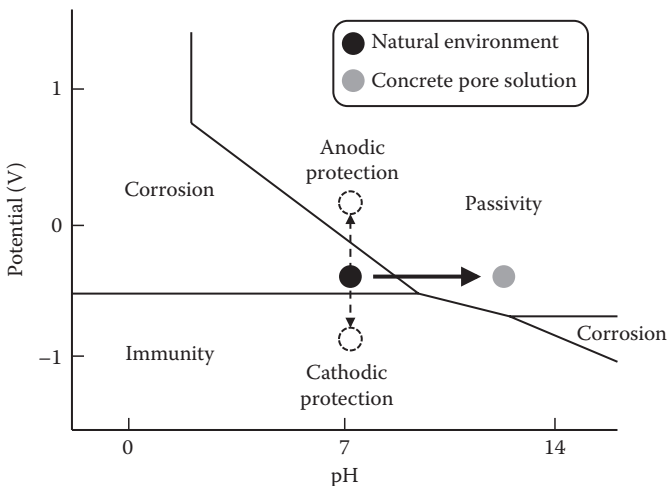
Figure 5.39 (Simplified) Pourbaix equilibrium diagram for iron in aqueous environment.

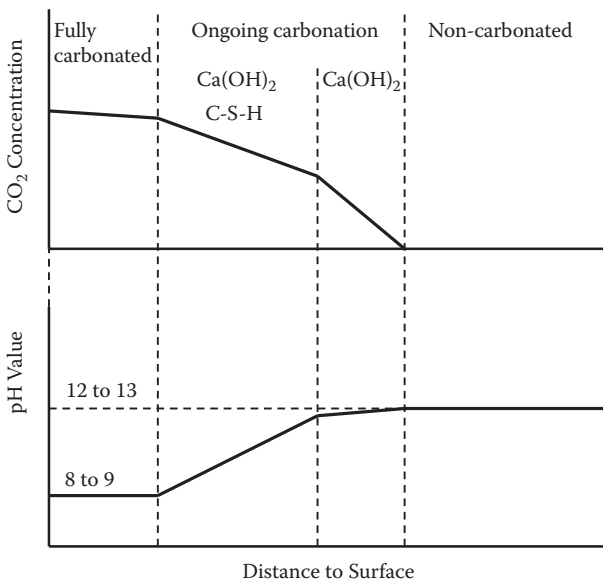
Figure 5.41 Evolving carbonation front in concrete: CO_2 concentration and pH value as a function of the distance to the exposed concrete surface.

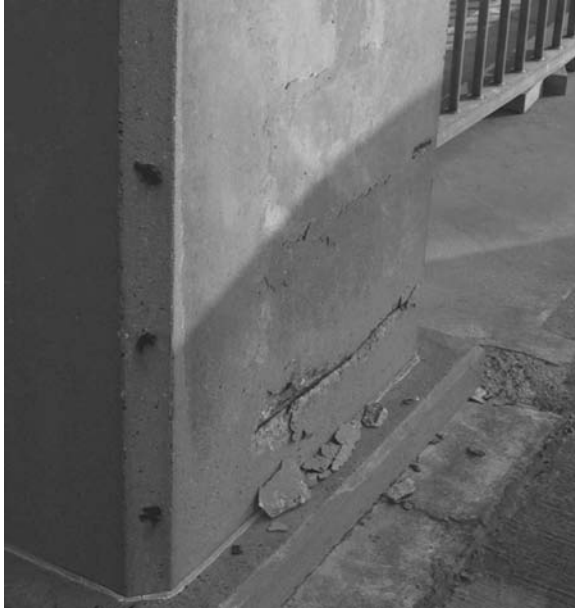
Figure 5.45 Carbonation-induced corrosion in a column.

Typical examples of reinforced concrete structures affected by carbonation-induced corrosion can be found in residential and office buildings in many areas, as illustrated in the case of a concrete column of an office building shown in Figure 5.45. During the corrosion process, expansive formation of corrosion products leads to internal stresses around the rebars. Cracks will be formed in the concrete cover along the rebars, and finally concrete will be pushed off. In many practical cases, damage due to carbonation-induced reinforcement corrosion occurs faster than anticipated due to insufficient cover depths.

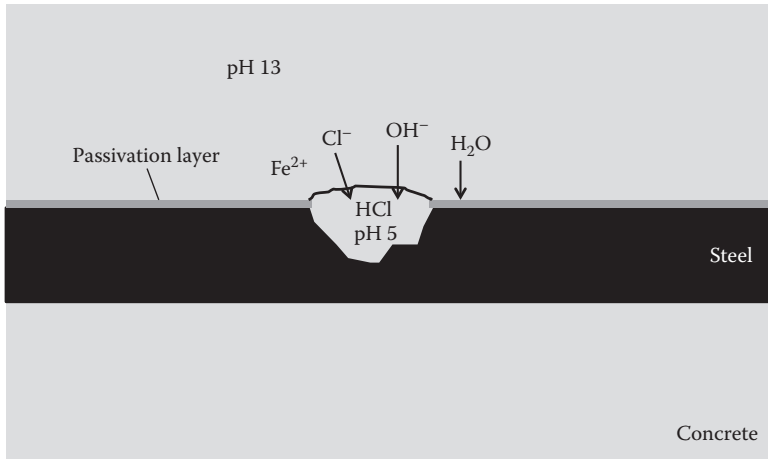
Figure 5.46 Chloride-induced pit corrosion of steel reinforcement in concrete.

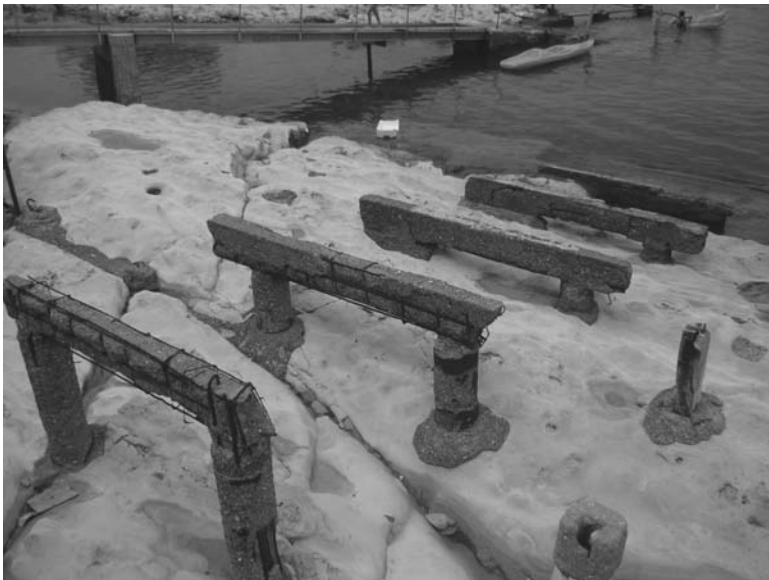
Figure 5.47 Chloride induced reinforcement corrosion in some concrete elements near the Adriatic Sea.

Chloride-induced corrosion of reinforcing steel in concrete can often be found in marine structures. An example is shown in Figure 5.47 for the case of some concrete elements near the Adriatic Sea. Severe damage is

already visible, with large areas of concrete cover pushed off by the expansive corrosion products. Again, it can be seen that the extensive corrosion in this case is most probably related to insufficient cover thickness.
